GOOSE CREEK LAKE DAM ST. FRANCOIS COUNTY, MISSOURI MO 30297

PHASE 1 INSPECTION REPORT NATIONAL DAM SAFETY INSPECTION

JUNE 1981

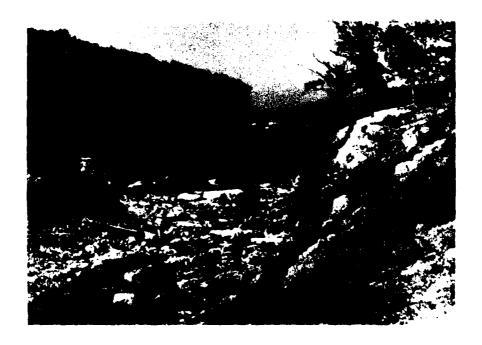
The spillway was excavated by blasting in the left abutment. The spillway was deepened approximately 2 ft in 1975 also by blasting to lower the lake level. No significant siltation was noted at the upstream end of the reservoir following the lowering of the lake.

6. Spillway excavated at left (north) end of dam. Note remnants of concrete spillway weir in front of observer. Looking southwest from left bank of discharge channel.

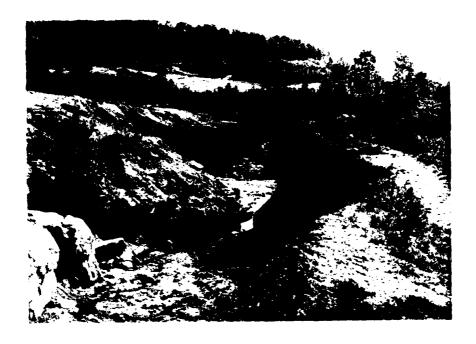
appears to be continuing in the channel and small slumps were noted along portions of the channel walls. However, none of these slumps appears large enough to pose a significant obstruction to flow in the channel.

Downstream discharge channel. Note small soil slumps along portions of the banks of the channel. Looking east, downstream.
